DECLARATION OF COLE LELEUX

1. I am currently the CEO of Spike's Tactical, an AR-15 Manufacturer
2. I directed the creation of two videos at the request of Rare Breed Triggers.
3. One video shows a Spike's Tactical receiver assembled into an AR-15 and fitted with a FRT-15 Rare Breed forced reset trigger. The receiver is milled out to make the internal mechanisms readily visible. This alteration did not impact the function of the trigger or receiver.

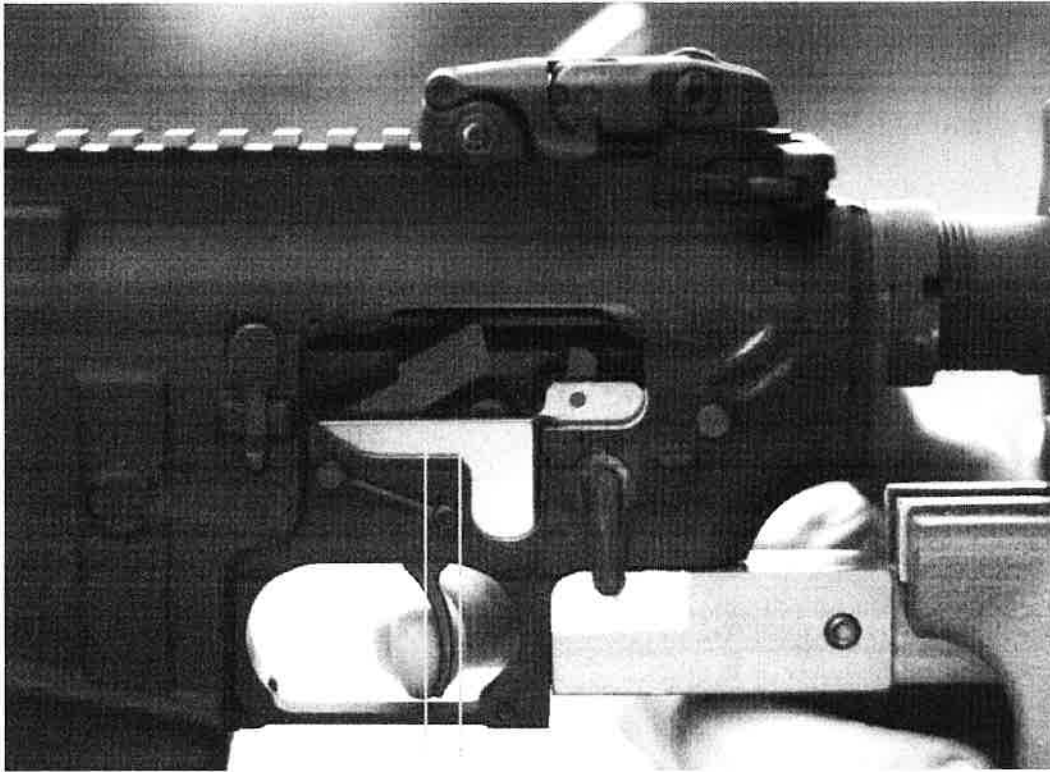
- f. This rearward movement is the take up being removed from the trigger. In this moment (pictured below), the hammer is captured by the trigger sear surface just as it is with any other standard AR-15 Semi-Automatic trigger
